# Klamath National Forest Best Management Practices

REGION 5  
EVALUATION PROGRAM  
WATER QUALITY  
MONITORING REPORT  
**2016 Fiscal Year**

January 20, 2017

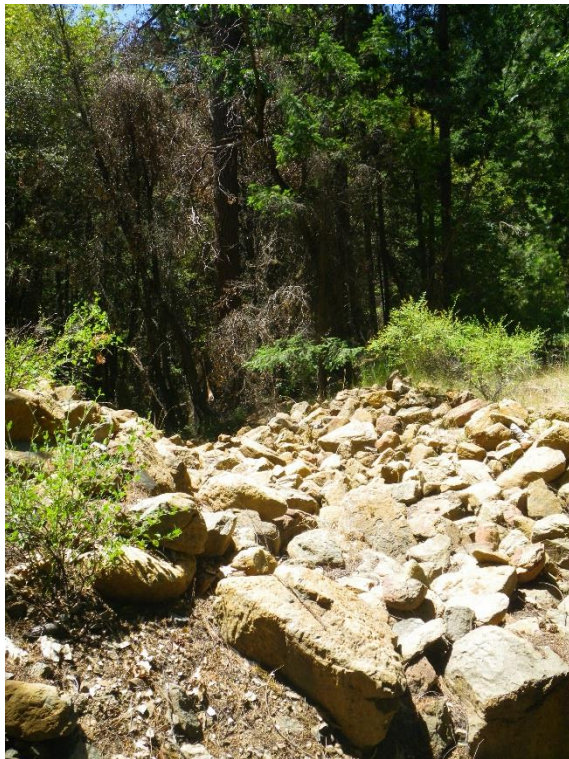
The E10 evaluation was completed on the 46N64.1A road in the Tompkins Creek Watershed on the Scott River Ranger District. The section of road that was decommissioned was about 1.5 miles. There were 5 road crossings of which treatments were varied. The first crossing was over a moderately sized ephemeral swale. There was no culvert in the crossing. The fill was reduced into a critical dip and the fill was armored with rip-rap. There was a small rill cross the roadbed but the rip-rap kept it from downcutting into the fill. The second crossing had all of the fill removed. The slope of the channel through the old road prism was stable and the fillslopes did not show any signs of rilling or erosion. The third crossing had the fill removed and it was completely armored with rock so there was no sign of downcutting or rilling on the fillslopes. The fourth crossing showed no sign of a culvert. The fill had been reduced and the fillslope was armored with rip-rap. The stream likely flowed during the July 2014 storms because there were signs of the channel flowing water over the roadbed. The rilling had begun to heal and grass was growing in it. The water was slowed by the rip-rap and no scour was observed below the roadbed. The final stream reviewed was at the end of the road on the edge of a small landing. There was no evidence of erosion from the landing into the stream channel. The landing was outsloped and had no rilling or evidence of standing water.

*Figure 1: Picture of the third crossing on the decommissioned road 46N64.1A looking down stream.*

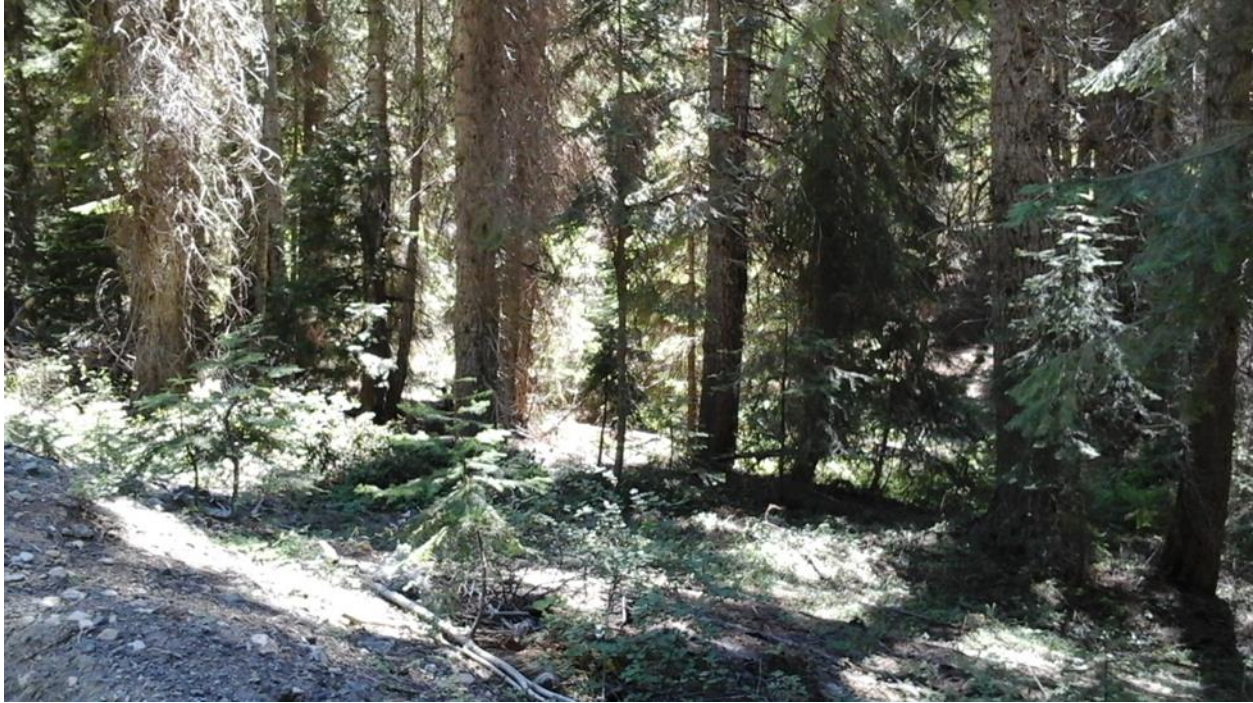
The southeastern boundary of Mt. Ashland LSR project unit 234 contains Riparian Reserve. Forest Service Road 40S15 is between the harvest unit and the branch of Long John Creek. There was no vegetation removed between the road and the stream channel or within 150 feet of the stream channel above the road. Since the stream runs parallel to the unit boundary there were no areas where heavy equipment had to cross the channel.

*Figure 2: Typical Riparian Reserve Condition along Long John Creek as it parallels Mt. Ashland LSR Project Unit 234.*

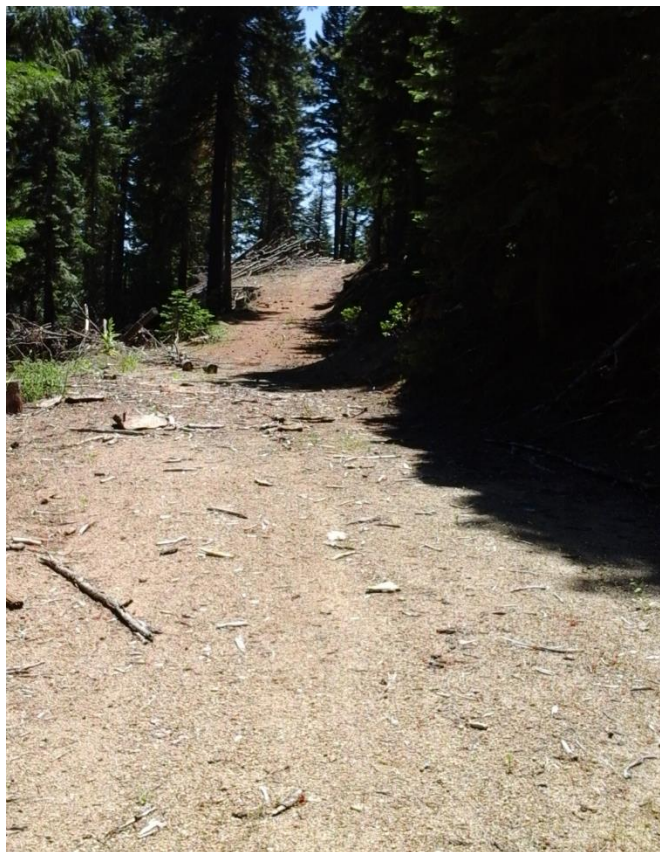
The temporary road reviewed was on the transportation map as a user created road. So it is a temporary road on existing roadbed. The project design features call for the road to be hydrologically stabilized and the take-off-obiterated once the fuel piles have been burned or removed. The road is ridgetop and there are no crossings. There were dips in the road that were effectively minimizing the rilling on the native surface roadbed (granitic bedrock). The skid roads leading from the unit to the road have been waterbarred and bermed. There is no sign of use of these roads and the waterbars are in working order. The take off to the temporary road on existing roadbed has not been obliterated because the fuel piles are still at the landings per the project design features. The roadbed was widened slightly using heavy equipment by cutting into the cuteslope with a bulldozer. Despite this disturbance the cut slope appears to be stable and there were no landslides on the roadbed during the time of visit.

*Figure 3: Steep section of the road where dips are effective in minimizing rilling in Mt. Ashland LSR unit 347.*

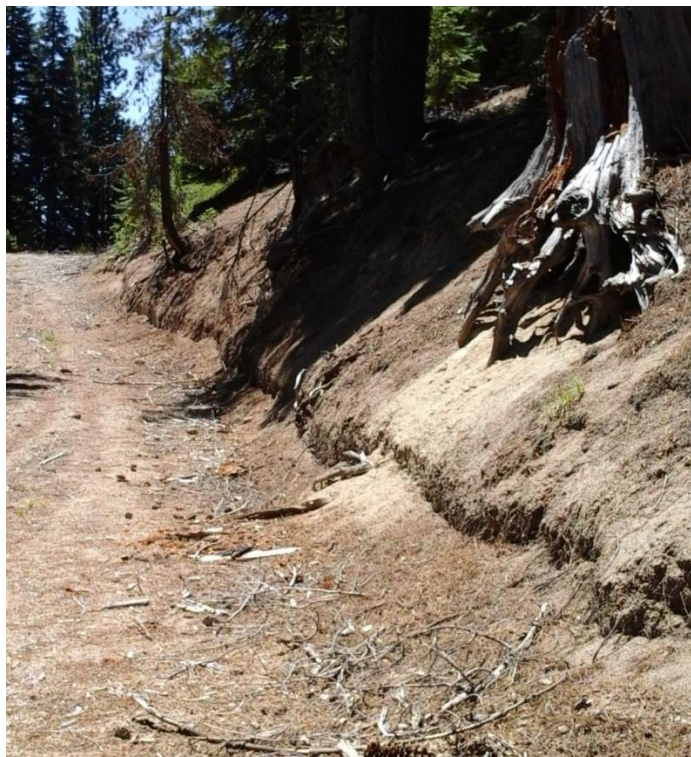
*Figure 4: disturbance on cut bank along temporary road in Mt. Ashland LSR unit 347*

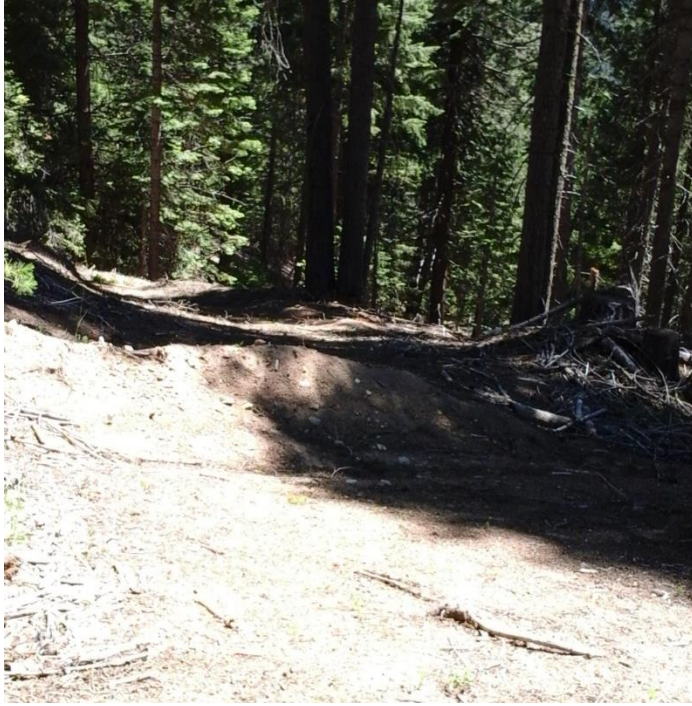
*Figure 4: Berm on skid road crossing the temp road in Mt. Ashland LSR unit 347.*

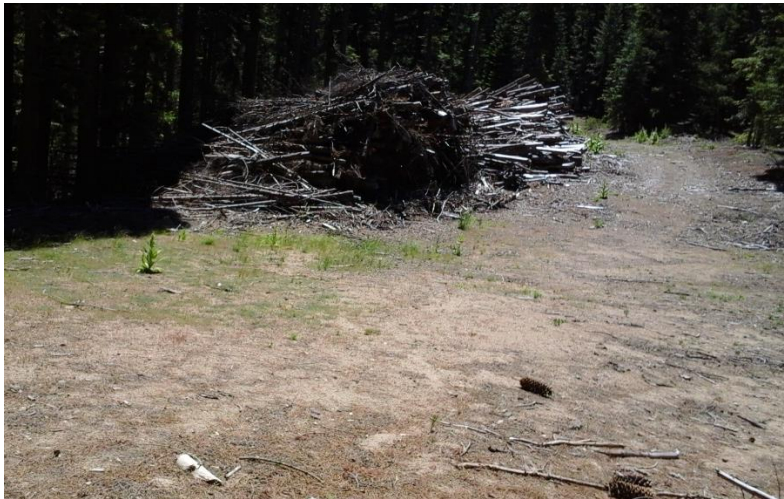
*Figure 5: Fuel piles at landing along road in Mt. Ashland LSR unit 347.*

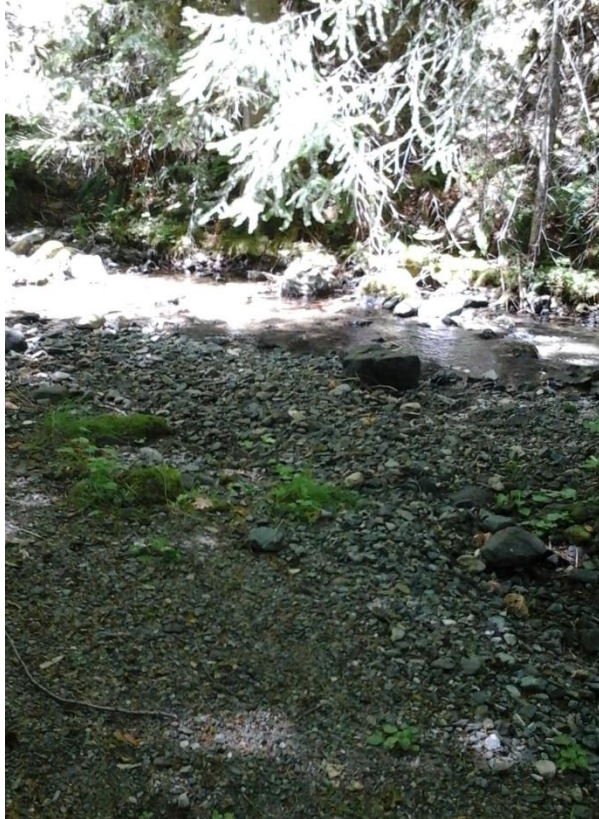
The water source is located on Rays Creek which is a tributary to the South Fork Salmon River. The only development associated with the water source is a short access road (~25 feet). The road is gentle (less than 10% grade) and adequately rocked to prevent any rilling or sediment delivery to the stream. There is no “hole” developed, the drafting was done directly from the creek channel. The vegetation was unmodified and is providing shade to the perennial stream.

*Figure 6: Approach to water drafting site on Rays Creek.*
